Service Bulletin

Product Family: Ariens Equipment with General Transmission Drives

Subject: Diagnosis and Repair Information Available

No. B-2153

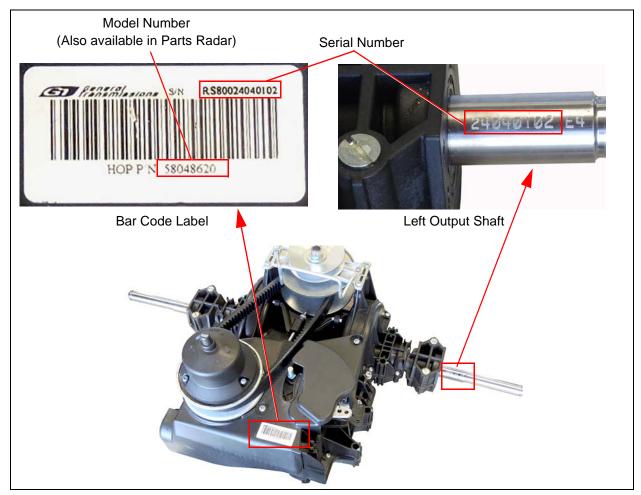
The product information number is located in the top right corner of the bar code label on top of the transmission. The same number is engraved on the left output shaft. The model number is found at the bottom of the label.

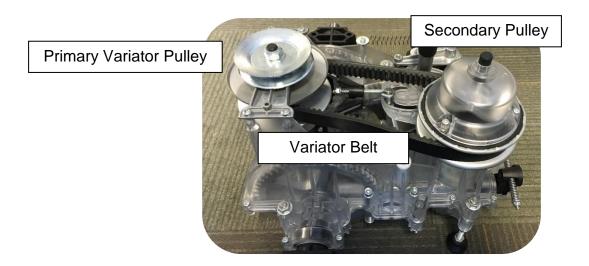
It is driven by a belt connected to the engine crankshaft. Based on input from the operator, it powers a wide drive belt called the "variator belt" to provide input power to the transmission.

The secondary pulley is connected to the primary pulley by the variator belt and when turned it provides power into the transmission.

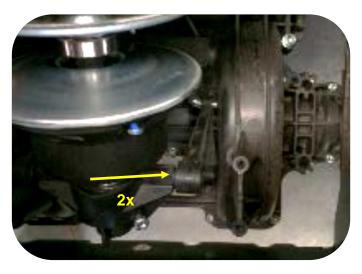
Step 4) Clean debris from area

Cause: The most common cause of this symptom is debris accumulation under and around the primary variator pulley. The debris prevents the proper operation of the pivoting control, and the pulley is kept partially engaged rather than returning to a neutral position.

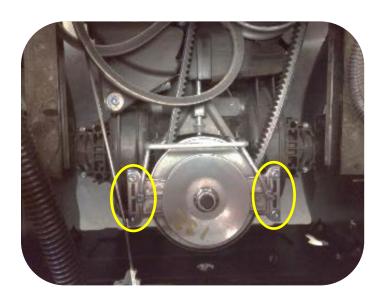
Step 7) Install variator pulley and tighten 4 mounting screws. Use Loctite® 454 or similar. Ensure that both variator levers are properly seated in the housing.

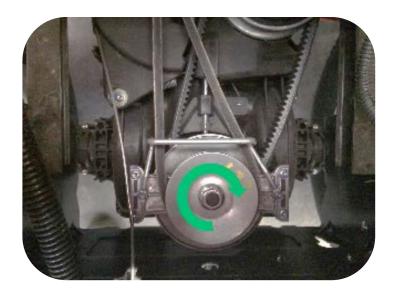
Step 8) Ensure variator pulley rotates freely and install drive belt in pulley.

^{*}Replace any damaged parts using service kit: GT78254 (for pedal version), or GT79325 (for fender version)

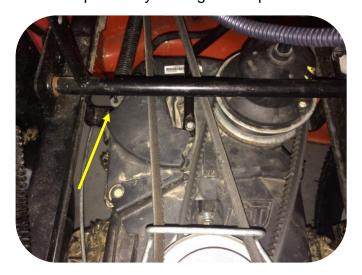
If the freewheel rod does not move in toward the tractor and reset when applying the brake, the brake lever (indicated by arrow below) on the transmission must be inspected for damage or interference. Replace any damaged components.

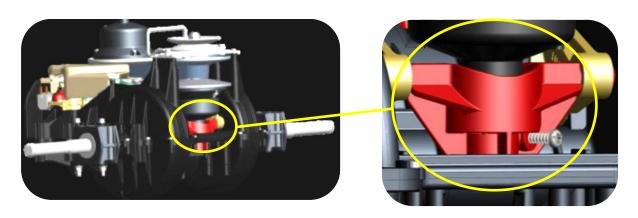
Note: Over-adjustment of the screw pictured below can lead to the tractor creeping in neutral. If this occurs, back out the screw until neutral is re-established.

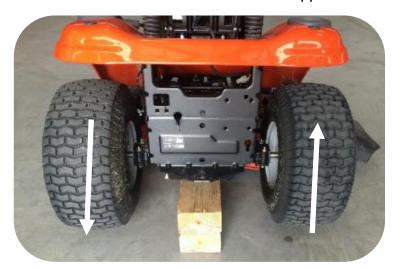
With the tractor in neutral "N" and rear of the tractor raised off the ground, manually rotate one wheel. The other wheel should rotate in the opposite direction.

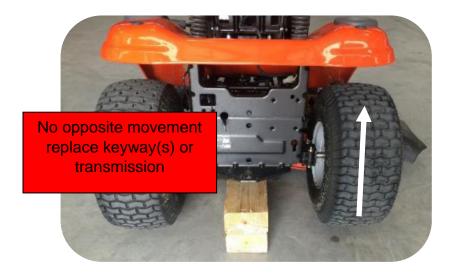
If the other wheel does not rotate in the opposite direction, verify keyways in BOTH wheels. If keyways in both wheels are intact, transmission must be replaced.

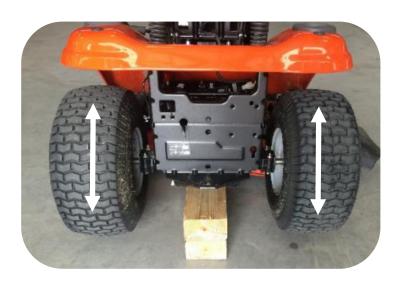
PARKING BRAKE MUST BE RELEASED DURING TEST

While keeping the tractor engaged in either forward or reverse, manually rotate the secondary pulley. While manually rotating the secondary pulley, the rear wheels should turn. If the wheels do not turn while turning the secondary pulley with the unit in gear, the transmission must be replaced.

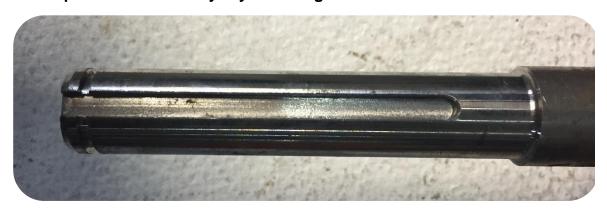
Reference phots VA5: Axle keyway undamaged

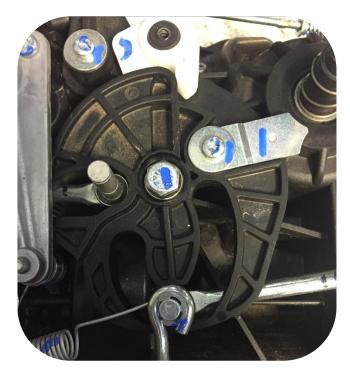
Reference photo VA9: Visual damage check of cam and components

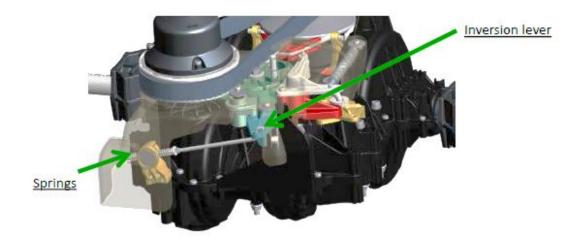
Reference photo VA10: Inversion lever location

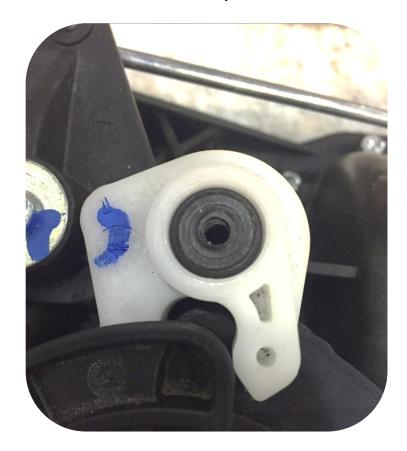
Reference photo VA11: White lever correct position

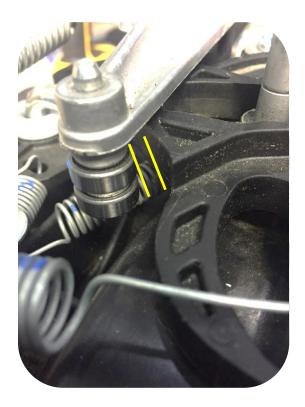
Reference photo VA12: Control cam 5mm gap

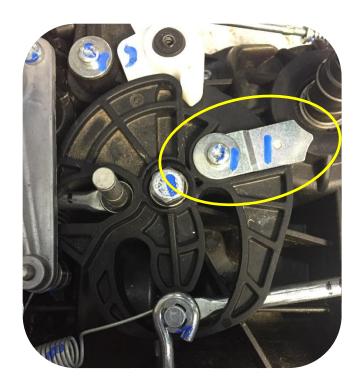
Reference photo VA13: Metal tab pivots freely
